**FEDERAL AVIATION ADMINISTRATION
AIRWORTHINESS DIRECTIVES
LARGE AIRCRAFT**

BIWEEKLY 2000-03

Biweekly 2000-03

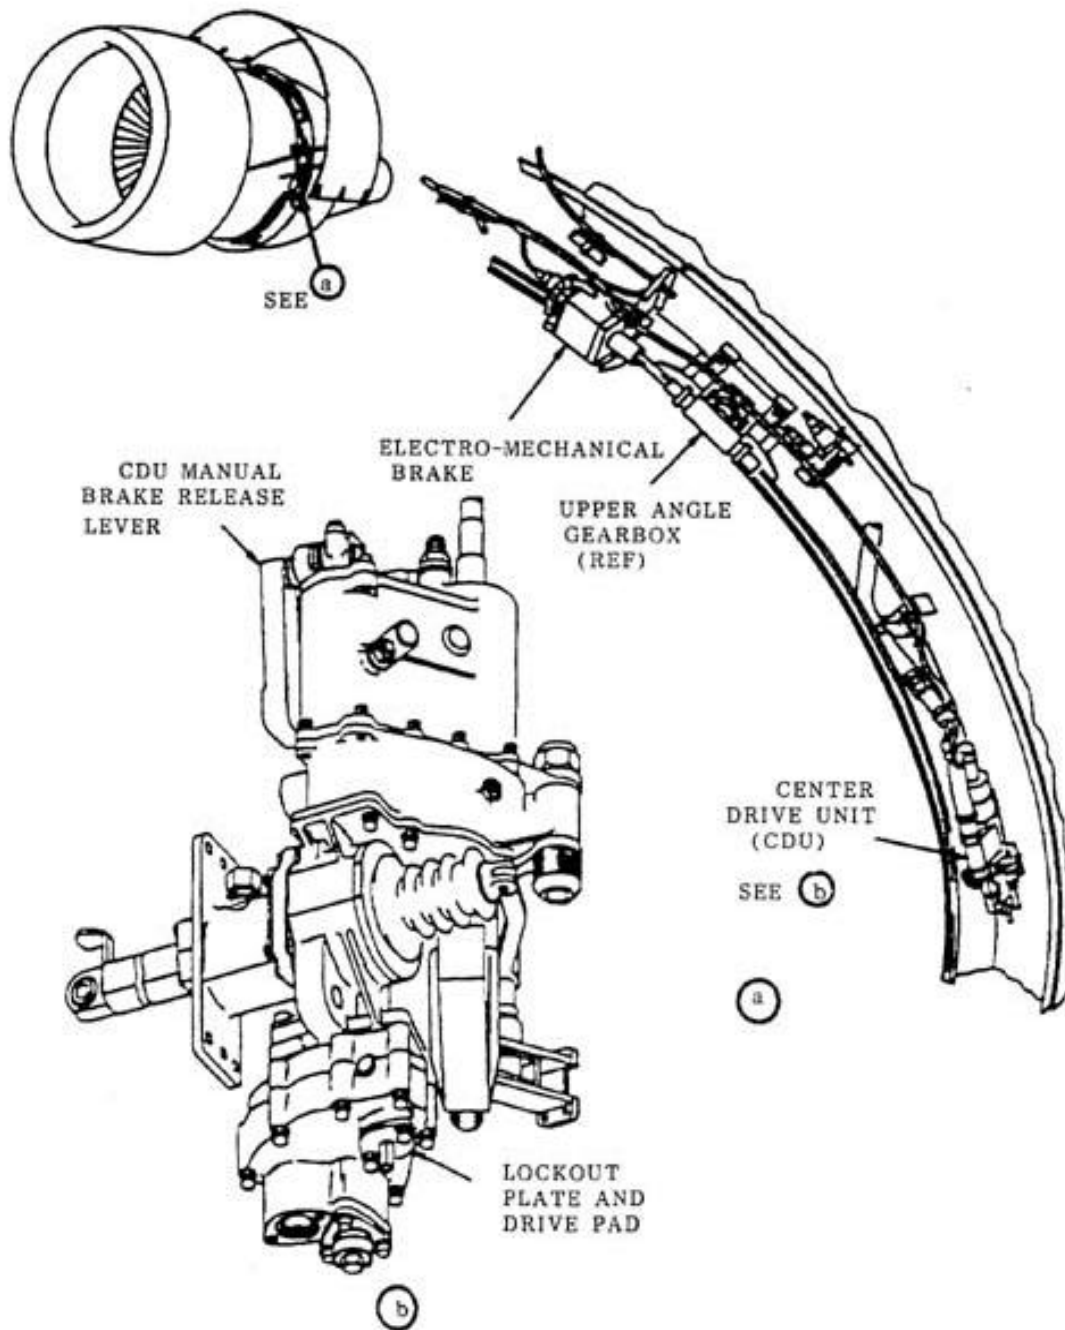
Figure 1

Electro-Mechanical Brake and CDU Cone Brake Torque Check

(including Figure 1), sections 1.A.(2), 2.A., 2.C., and 2.D of this AD. Accomplish the functional test at the time specified in paragraph (d)(1) or (d)(2) of this AD, as applicable.

2. Electro-Mechanical Brake and CDU Cone Brake Torque Check (Fig. 1)

- (e) Apply 90 pound-inches of torque to the system.
 - 1) The electro-mechanical brake system is working correctly if the torque is reached before you turn the wrench 450 degrees (1-1/4 turns).
 - 2) If the flexshaft turns more than 450 degrees before you reach the specified torque, you must replace the long flexshaft between the CDU and the upper angle gearbox.
 - 3) If you do not get 90 pound-inches of torque, you must replace the electro-mechanical brake.
- (f) Release the torque by turning the wrench in the opposite direction until you read zero pound-inches.
 - 1) If the wrench does not return to within 30 degrees of initial starting point, you must replace the long flexshaft between the CDU and upper angle gearbox.
- (3) Fully retract the thrust reverser.

CAUTION: DO NOT USE MORE THAN 100 POUND-INCHES OF TORQUE WHEN YOU DO THIS CHECK. EXCESSIVE TORQUE WILL DAMAGE THE CDU.

- (a) If the torque is less than 15-pound-inches, you must replace the CDU.

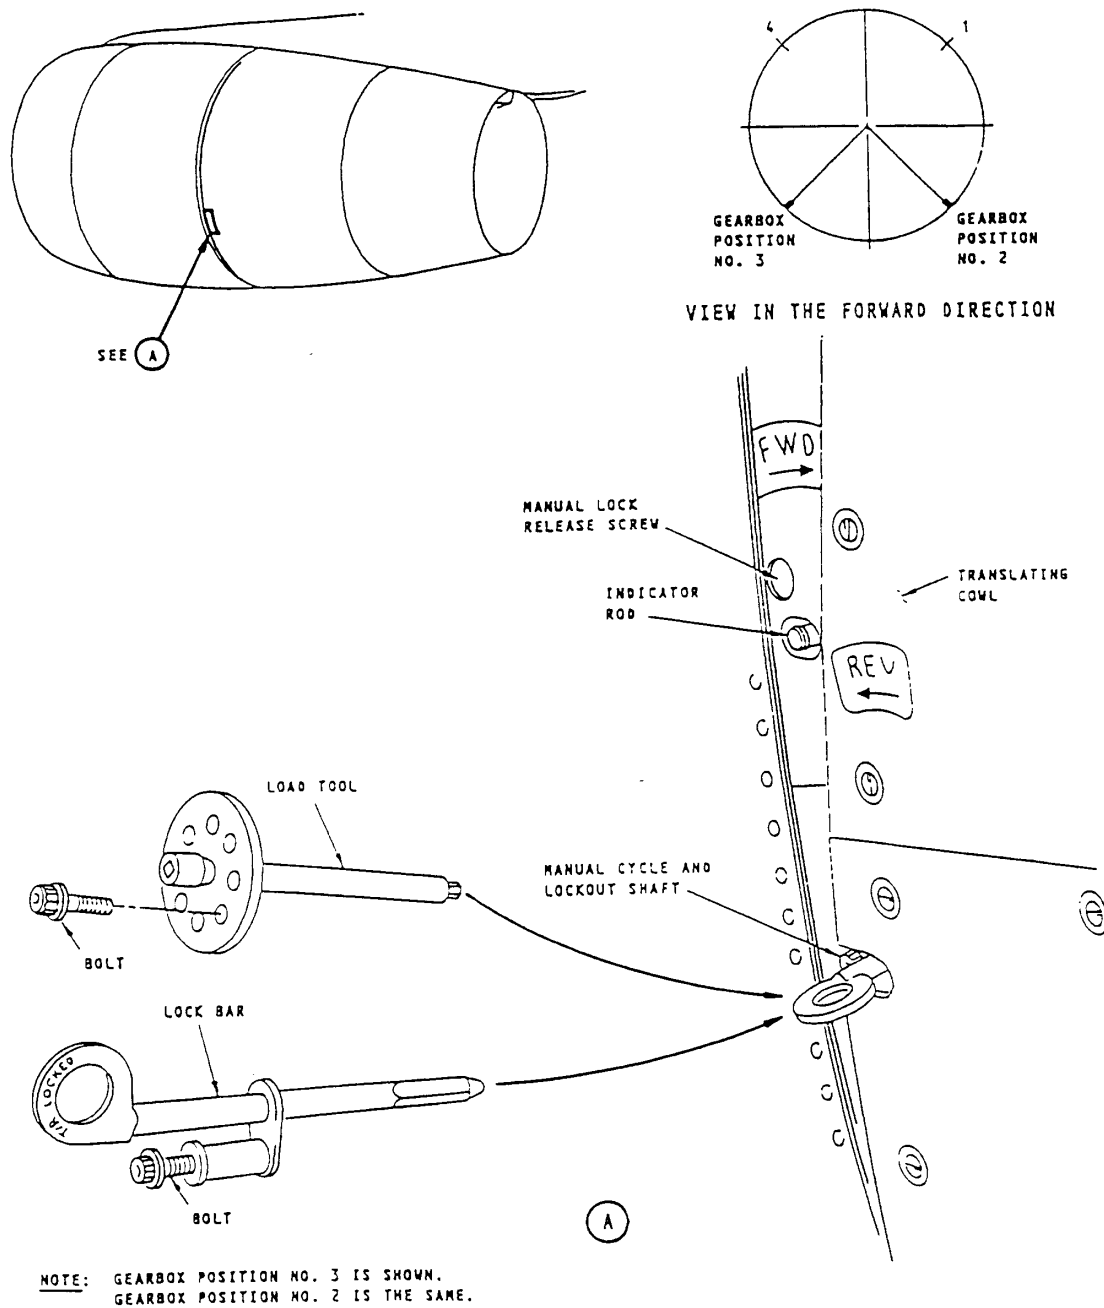
Lock Bar/Load Tool Installation and Gearbox Manual Lock Release
Figure 1

(b) Within 3,000 flight hours after accomplishing the requirements of paragraph (a) of this AD, or within 1,000 flight hours after the effective date of this AD, whichever occurs later: Perform operational checks of the number 2 and number 3 gearbox locks and of the air motor brake, in accordance with the procedures described in Appendix 1 (including Figure 1) of this AD. Repeat the operational checks thereafter at intervals not to exceed 3,000 flight hours.

(c) If any operational check required by paragraph (b) of this AD cannot be successfully performed as specified in the procedures described in Appendix 1 (including Figure 1) of this AD, or if any discrepancy is detected during any operational check, prior to further flight, repair in accordance with the procedures specified in the Boeing 747 Airplane Maintenance Manual. Additionally, prior to further flight, any failed operational check required by paragraph (b) of this AD must be repeated and successfully accomplished. Repeat the operational checks thereafter at intervals not to exceed 3,000 flight hours.

C. Procedure (Fig. 1).

- a) Attach the standard drive tools.
 - 3) Try to move the translating cowl in the extend direction.
 - (c) If the translating cowl moves, replace the air motor and shutoff valve.
